The Locomotive

THE HARTFORD STEAM BOILER
INSPECTION AND INSURANCE CO.

VOL. XXXVIII

HARTFORD, CONN.
1930-1931

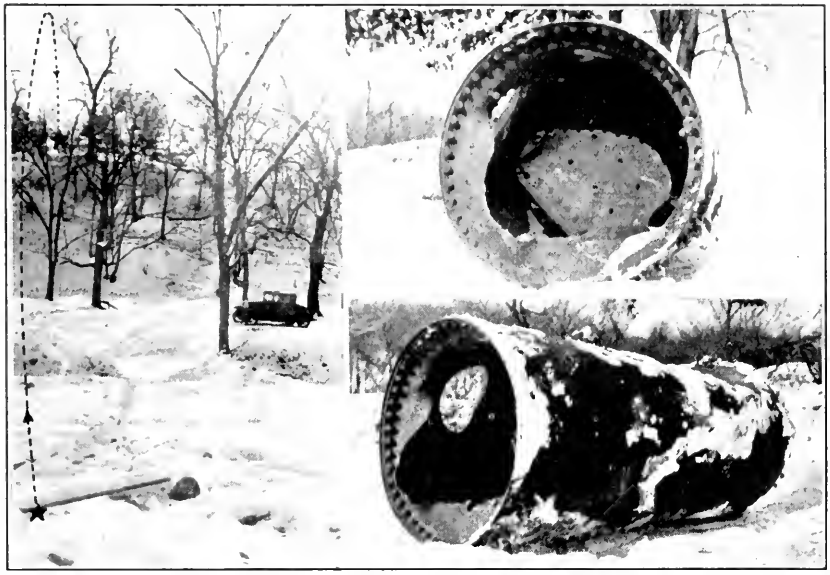
After the explosion—the boiler and where it went. The view at the left will give a good idea of the path of the Marseilles, Illinois, mine boiler. It followed approximately the path indicated by the broken line, passing upward over the trees and hill to a resting place 700 feet distant. The pictures at the right show end and side views of the boiler, the former revealing how the firebox was forced up against the tubes, and the latter showing the firebox opening and the dent caused when the boiler landed.

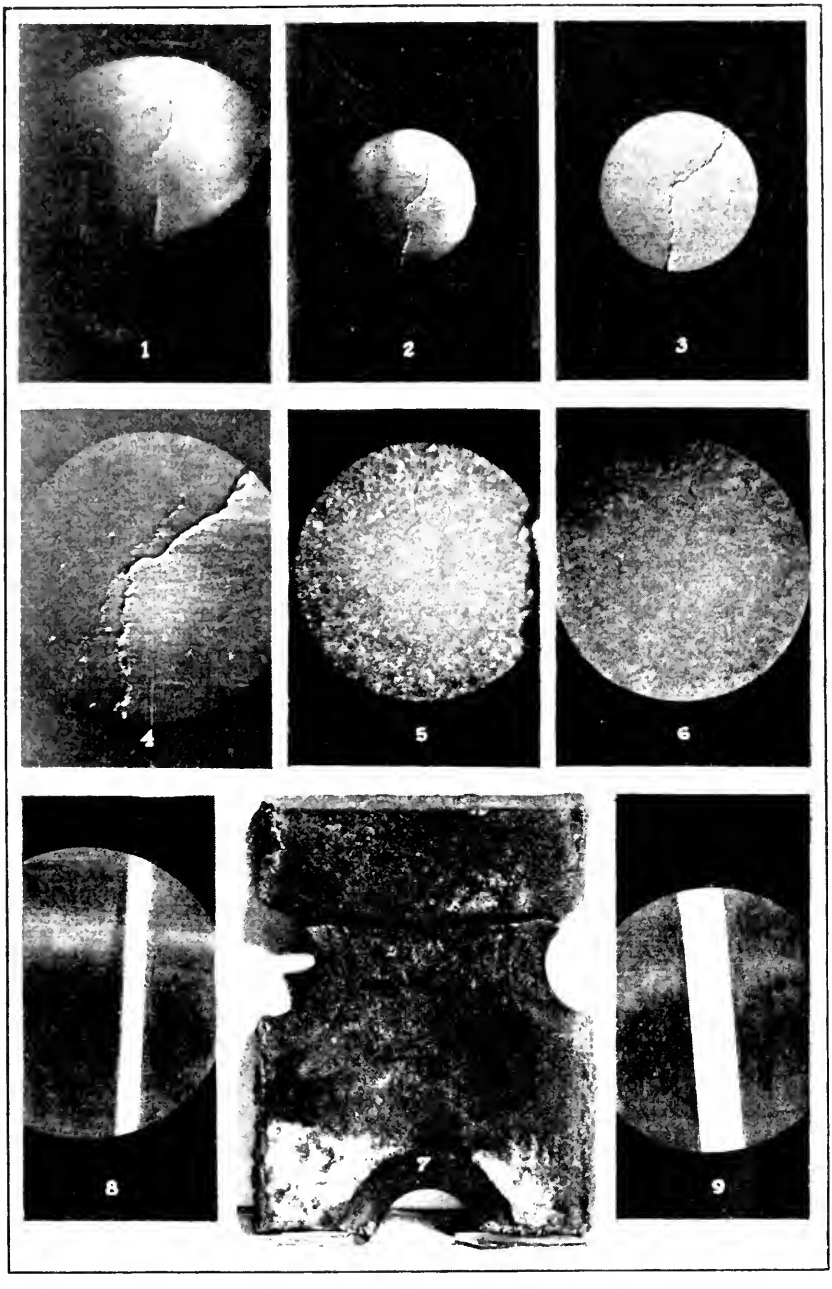
Photograph No. 3, taken with the magniscope and camera attachment of the latest design, is of the same defect at about 20 magnifications. In this photograph the true nature of the embrittlement defect becomes clearer. What is seen in the photograph is not a large fissure with branches, but rather the junction of two large fissures, the one progressing upward in the photograph and the other downward. Thus the complete defect, which extends the full width of the boiler plate, was formed by the joining of two independent fissures, each progressing from the surface of the plate. Further investigation, after the plates forming the butt strapped seam had been separated, brought to light the fact that each of the two lines of cleavage, while appearing to unite at the wall of the rivet hole really extended independently of each other

How caustic embrittlement cracks appear through the magniscope.

through the material of the plate in the direction of an adjacent rivet hole. These two fissures progressing from one rivet hole to another tended to make a section of the plate between them a sort of island cut off from the rest of the plate.

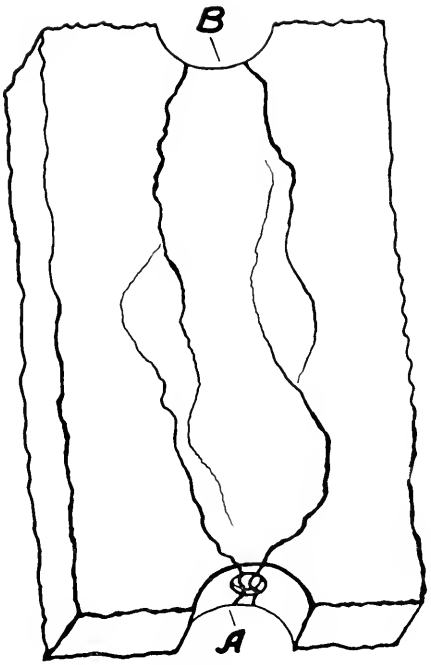
Fig. 10.

how far they extend into the plate, whether 1/8", 1/4" or the entire distance to the next rivet hole. To determine whether the embrittlement has eaten only a short distance or whether it is more serious, a hole (see Figure 10-A) is routed into the side of the rivet hole where the crack was found by means of the magniscope. A dental drill or burr has been used with some success in excavating a cavity to a depth of 3/16" into the plate, but an especially designed combination of motor, flexible shaft and milling tool was used in exploring the particular defect shown in the photographs. With this tool a cavity 1/4" wide was milled into the steel plate to a depth of 1/4". This exploration revealed conclusively that the fissures extended more than 1/4" into the plate, and further investigation showed that they extended practically from rivet hole to rivet hole. Exploration in other rivet holes revealed a veritable network of cracks developing simultaneously through the plate. Had the cracks penetrated to a depth of only 1/8" the progress of the disease might have been checked by reaming the rivet holes oversize and reriveting the seam.

Figure 10 is a drawing of a section of plate cut from a scrapped drum. In the case in point the development of fissures from two adjacent rivet holes was studied and charted. Two of the fissures passed

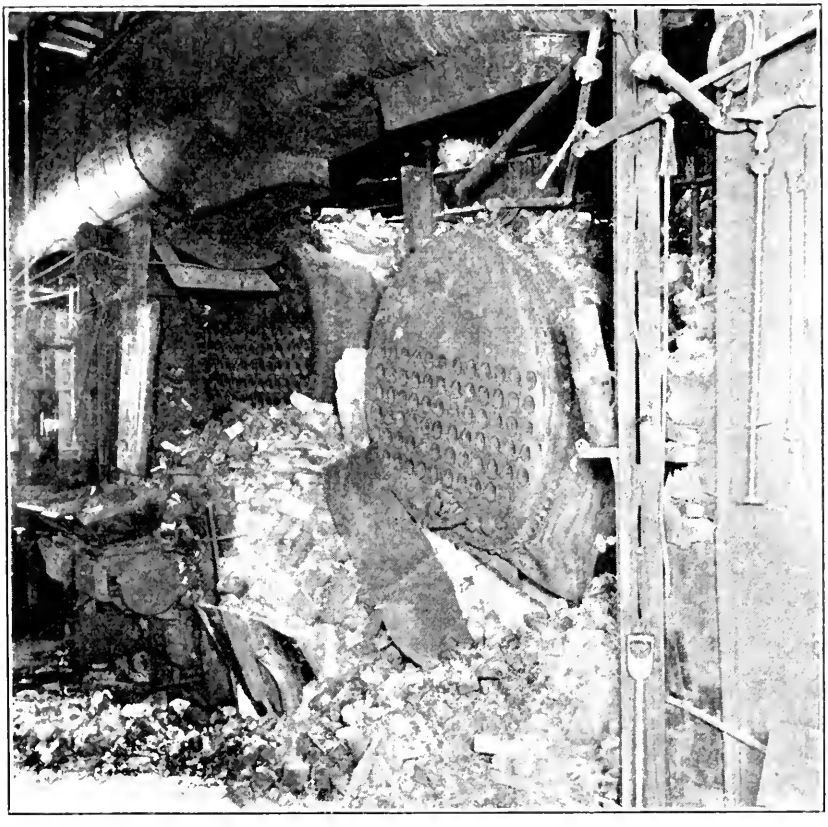
After dairy boiler bulged and ruptured

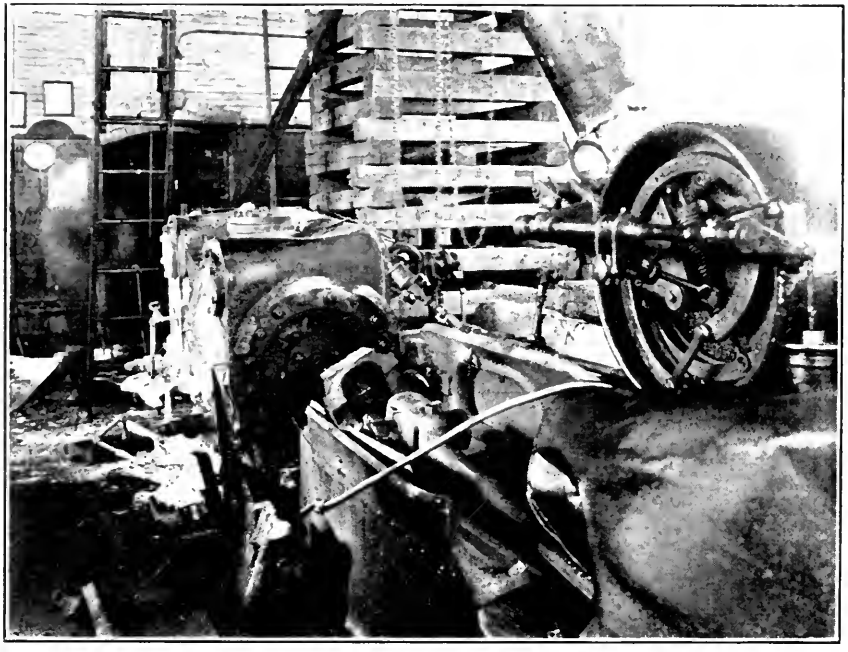
When the piston tried to compress water and the crosshead failed under the strain.

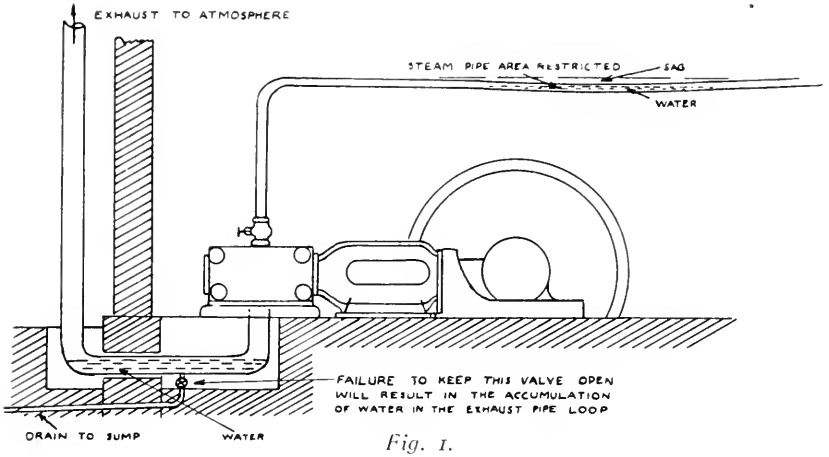
Fig. 1.

Water backing into the steam cylinder of a non-condensing engine from an atmospheric exhaust pipe. As a rule the exhaust pipe extends down from the engine, making a U-turn or loop and then leads to the atmosphere (Figure 1). It is very important that such a loop be properly drained at all times and the best arrangement is an open drain pipe leading down to a sump without any valves or traps. The open end of this drain should never be submerged in water. This is a frequently neglected feature because it is not generally understood that there is a

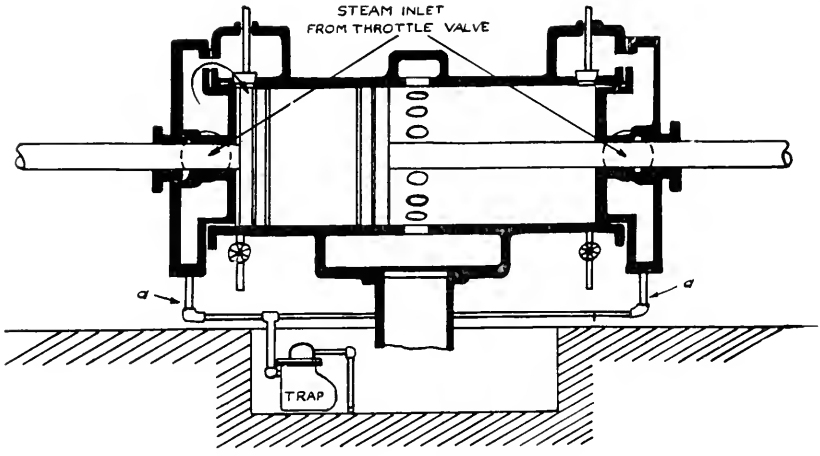
Fig. 2.

AUTOMATIC DRAINS FOR UNIFLOW CYLINDER HEADS

Improper drainage facilities on uniflow engine cylinder heads. The cylinder heads of a uniflow engine are as a rule steam-jacketed, that is, all the steam used by the engine enters through the cylinder heads. By the use of a baffle the steam then makes a complete sweep through the heads and finally enters the cylinder by way of the poppet valves. Since cylinder heads of this description necessarily form pockets (in the lower half) in which water can collect it is essential that suitable drains (See a-a Figure 2) be provided at the bottom of the heads.

A number of costly accidents to uniflow engines were caused by neglect of this drainage feature. In these cases it was ascertained that water had accumulated in the bottom of the cylinder heads while the

The proper safeguard against this condition is the continuous drainage of the cylinder heads by means of a steam trap. Preferably there should be no valves in the drain lines from the cylinder heads to the trap as these valves might be inadvertently closed. In some cases the operators have mistaken the drain valves on the cylinder heads for cylinder drains and have closed them.

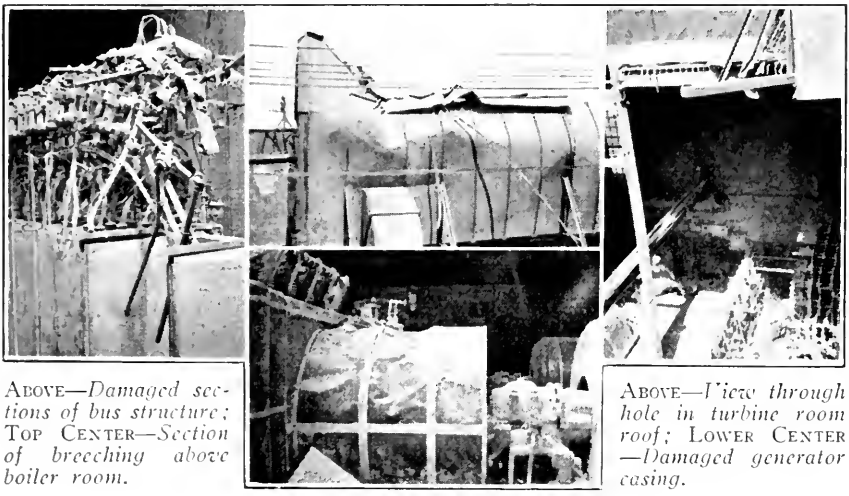
ABOVE—*Damaged sections of bus structure;* TOP CENTER—*Section of breeching above boiler room.*

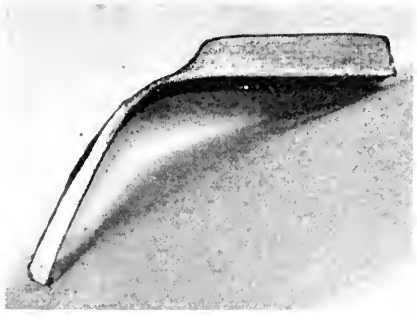
Figure 1—Cross section of "blind" head showing corrosion.

In a special checkup conducted during the past two years, this Company found that, of all bent tube boilers of which the mud drums were uncovered for inspection, the drum heads of about ten percent were affected by corrosion to such an extent that expensive repairs would soon be necessary. About one percent were in such dangerous condition that the boilers could no longer be operated without immediate repairs or, in some cases, replacement of the drum.

Figure 1 illustrates how serious this thinning down can become. This piece was cut from the mud drum head of a boiler which evidently could not have held together much longer under its working pressure of 150 pounds per square inch. At the bottom of the drum, and for some distance up each side, the sound metal at and near the turn of the head flange was not much thicker than a piece of heavy cardboard. In addition, the ends of the shell plate and rivet heads were very seriously eaten away. Because that portion of the head forming the skirt was protected by the end of the shell from contact with the ashes, it did not corrode. The head was originally of the same thickness throughout, so the illustration shows clearly the extent to which the half-inch plate was wasted. Over a considerable proportion of the circumference of the head at the turn of the flange about one-sixteenth inch of sound metal remained.

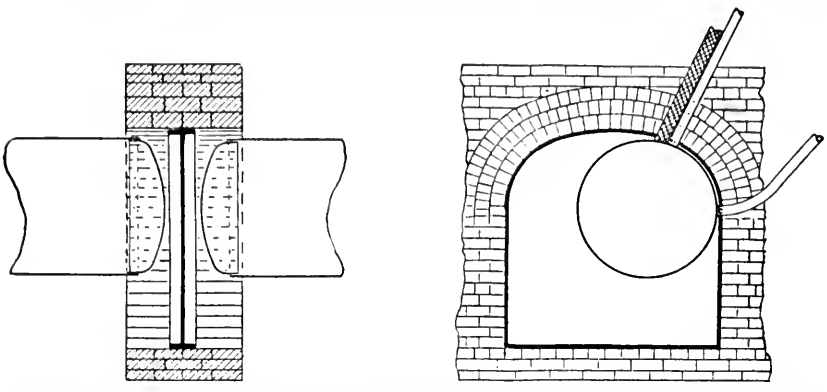
Figure 2—Ideal arrangement for blank heads of mud drums in battery setting.

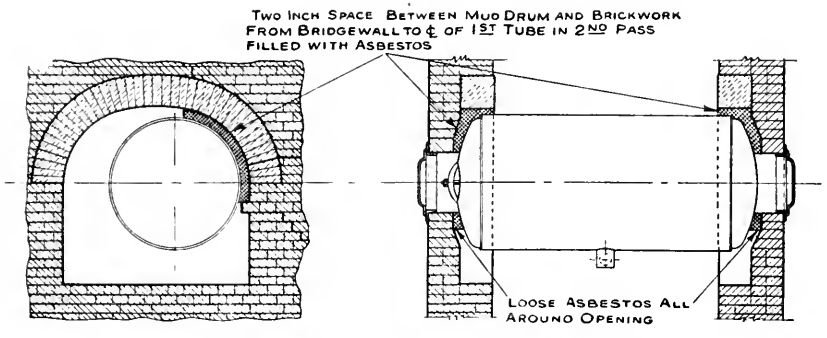
TWO INCH SPACE BETWEEN MUD DRUM AND BRICKWORK
FROM BRIDGEWALL TO ℄ OF 1ST TUBE IN 2ND PASS
FILLED WITH ASBESTOS
LOOSE ASBESTOS ALL
AROUND OPENING

Figure 3—Ideal arrangement for ends of bricked in drums.

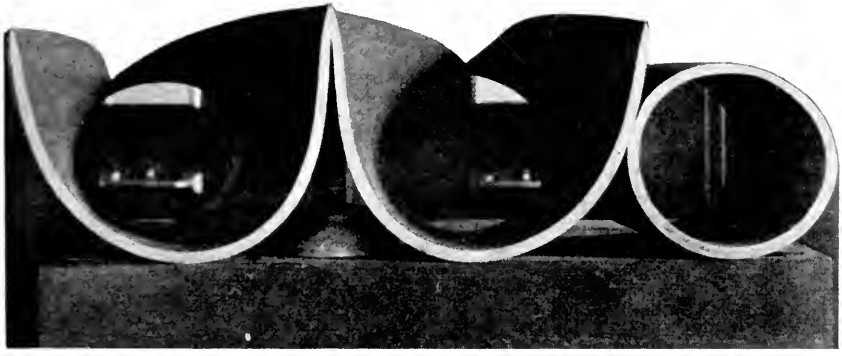
ALTHOUGH water-wall tubes do not fail as frequently as do main boiler tubes, failures are by no means uncommon, and the illustration shows a typical case that recently occurred. Such accidents, the result of overheating, can be looked for unless preventive means are considered both in the installation and in the operation of the boiler.

Examples of failure in water wall tubes.

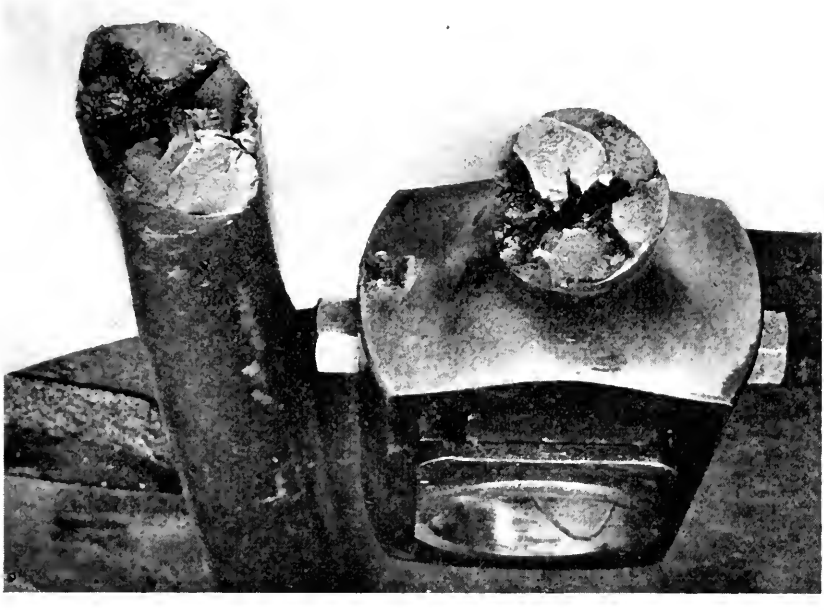
THE illustration shows the unusual forging flaw to which a recent serious engine accident was attributed. The large cross-compound engine went to pieces, damaging itself to the extent of more than $4,400.

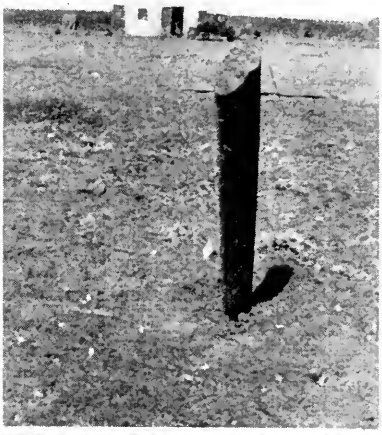
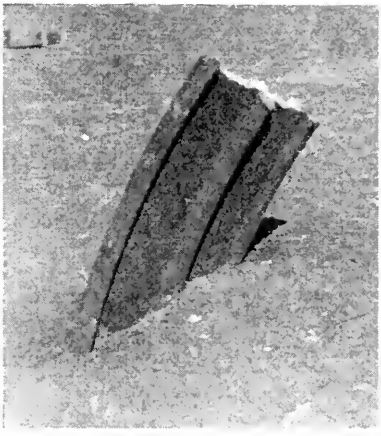
Occurrences, insignificant in themselves, may bring about catastrophic losses. Last February, in a cotton gin in the Texas Panhandle, the weakening of a gasket of a blow-off valve of a 72" horizontal tubular boiler caused leakage which was blamed for a severe engine accident.

Above—An arm of the wheel "javelin-minded".
Below—Piece of rim 200 yds. from the engine.

One theory was that the water leaking from the blow-off valve filled the wheel pit to such a level that the main driving belt lost its traction, and that this resulted in an alternate slipping and grabbing of sufficient severity to break the belt. There was some evidence to support the belief also that while this was occurring the governor belt slipped off either from the erratic behavior of the engine or because of becoming wet by water splashed up from the belt wheel. This governor belt had slipped off on previous occasions, attendants said, but this time the safety cams on the engine valve gear were not in proper position. The result was that the stopping of the governor failed to cut off steam from the engine, as it should have done. As the engine had been relieved of its load by the breaking of the main belt, overspeed developed quickly.

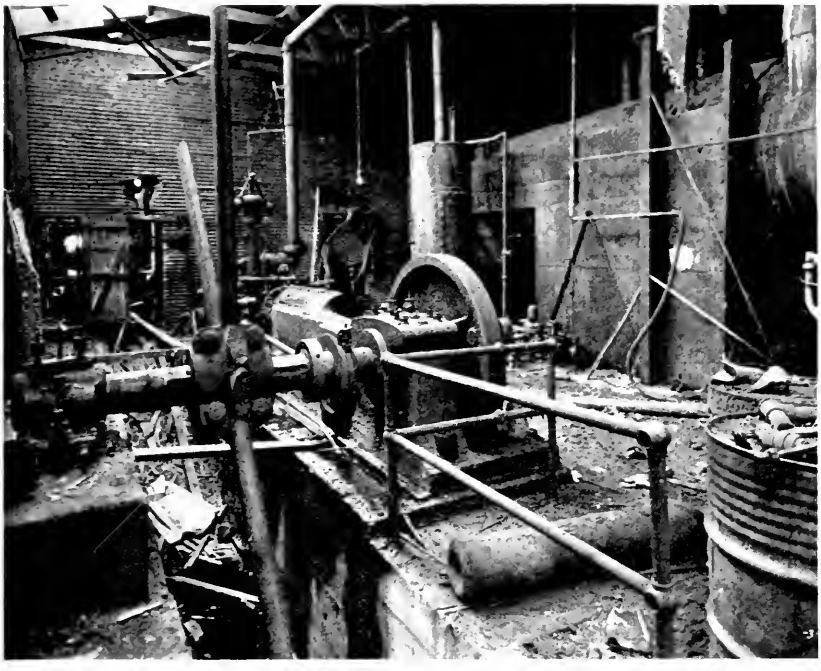
Engine room after the shattering of the flywheel. All that remains of the wheel is the hub and three spokes.

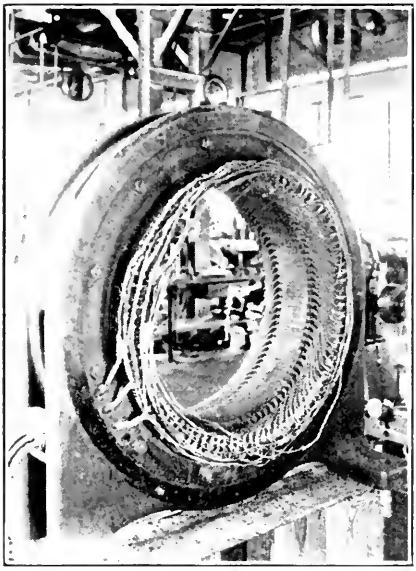
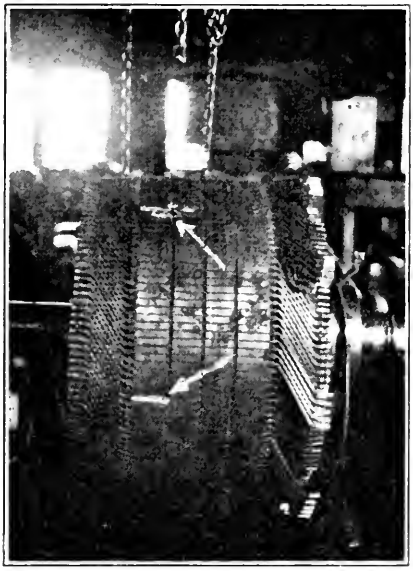
Left—Complete burnout of the stator windings. Right—Wound rotor of an induction motor showing damaged sections in the laminated core resulting from an insulation failure in the slots.

There are many kinds of accidents to motors. Some result from a misapplication of the motor to the job. Others can be attributed directly to lack of proper attention to the motor and its control equipment, to carelessness of the operator in starting and stopping, and to failure to protect windings against the harmful effects of moisture while the motor is out of service. Still others are due to causes arising outside of the motor, such as lightning, line surges, or single-phasing resulting either from line failure or the failure of a fuse in the motor circuit.

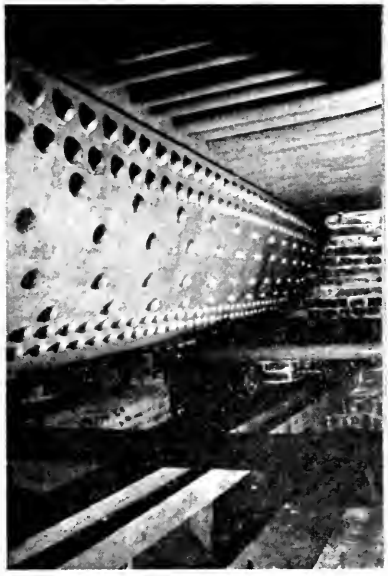
Exterior and interior views of boiler drum repaired with extra-wide straps to overcome weakness caused by caustic embrittlement.

several years of life to boilers that otherwise seemed destined for a quick retirement. All the boilers were of the bent tube type, and embrittlement had affected only the longitudinal seams in their lower drums.

THE expedient of applying wider butt straps as a repair of a seam that had been weakened by caustic embrittlement, was made use of recently on batteries of water tube boilers at two different locations in southern states. This form of repair is limited, of course, to cases where the embrittlement is in an early stage, and where the design of the boiler does not prevent the use of wider straps; but in the cases about to be described it was successfully used in adding
